ISOE ASIAN ALARA Symposium 2014  
on Occupational Exposure Management at Nuclear  
Facilities  
Gyeongju, South Korea, September 23-25, 2014

# Radiation Protection Management in Fukushima Daiichi NPS and Post-accident Measures

*Tokyo Electric Power Company,  
Radiation Protection and Management Group  
Shiro TAKAHIRA*

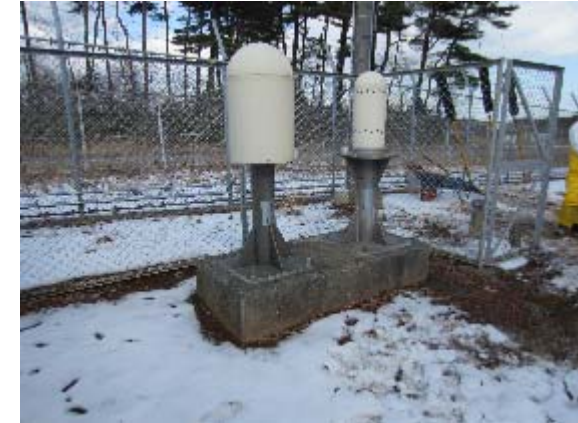
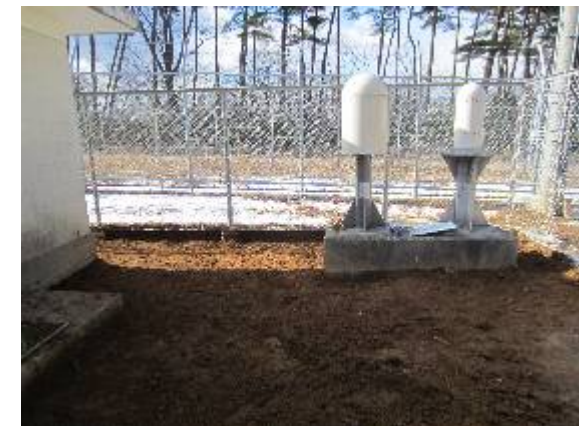
Monitoring post No.2

- Because of fallout, dose rate of monitoring post kept high level.
- We reduced the influence of fallout by surface soil stripping or shielding around monitoring post.

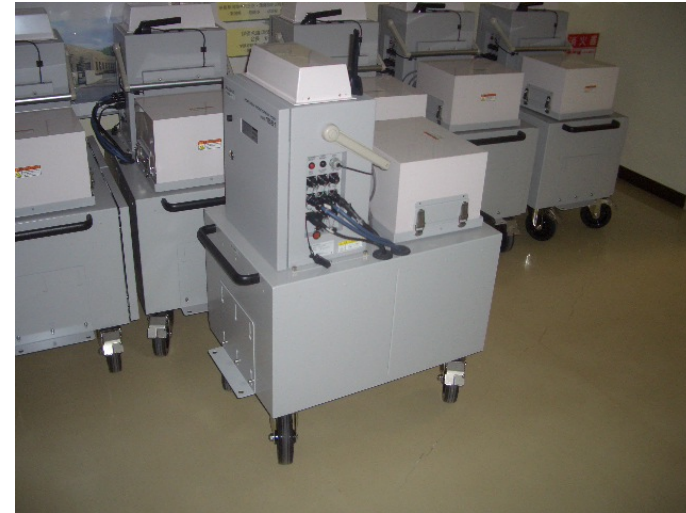
Portable monitoring posts

- Adding portable monitoring posts
- Reinforcing the power supply of monitoring posts (emergency generator)
- Reinforcing the transmission system of monitoring posts (satellite antenna)

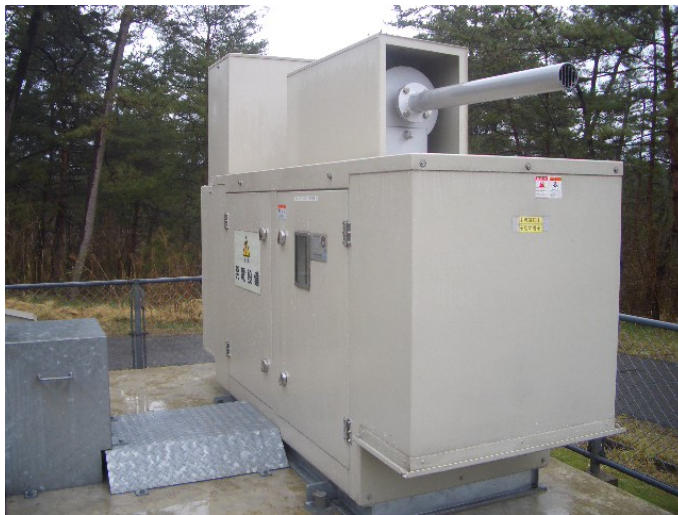
Generator to backup power supply to monitoring posts

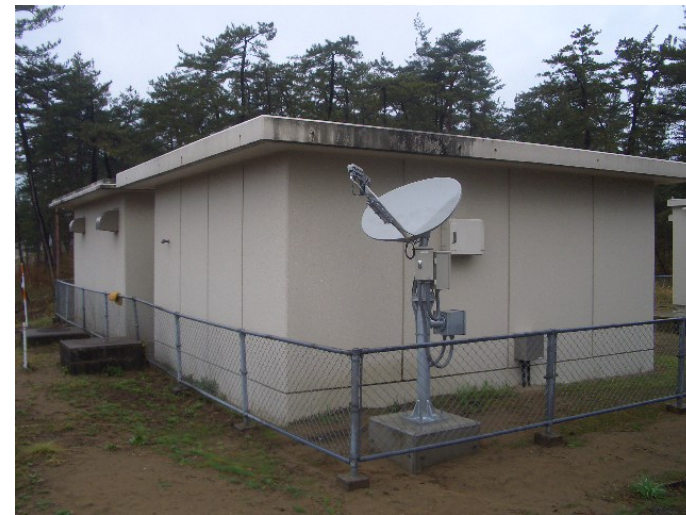
Satellite antenna for monitoring posts
