# **ALARA Aspects of the DC Cook Baffle Bolt/Upflow Modifications**

**David W. Miller, NATC Regional Director  
DC Cook Nuclear Plant, American Electric Power  
2018 ISOE International ALARA Symposium  
Kyoto, JAPAN, October 25, 2018**

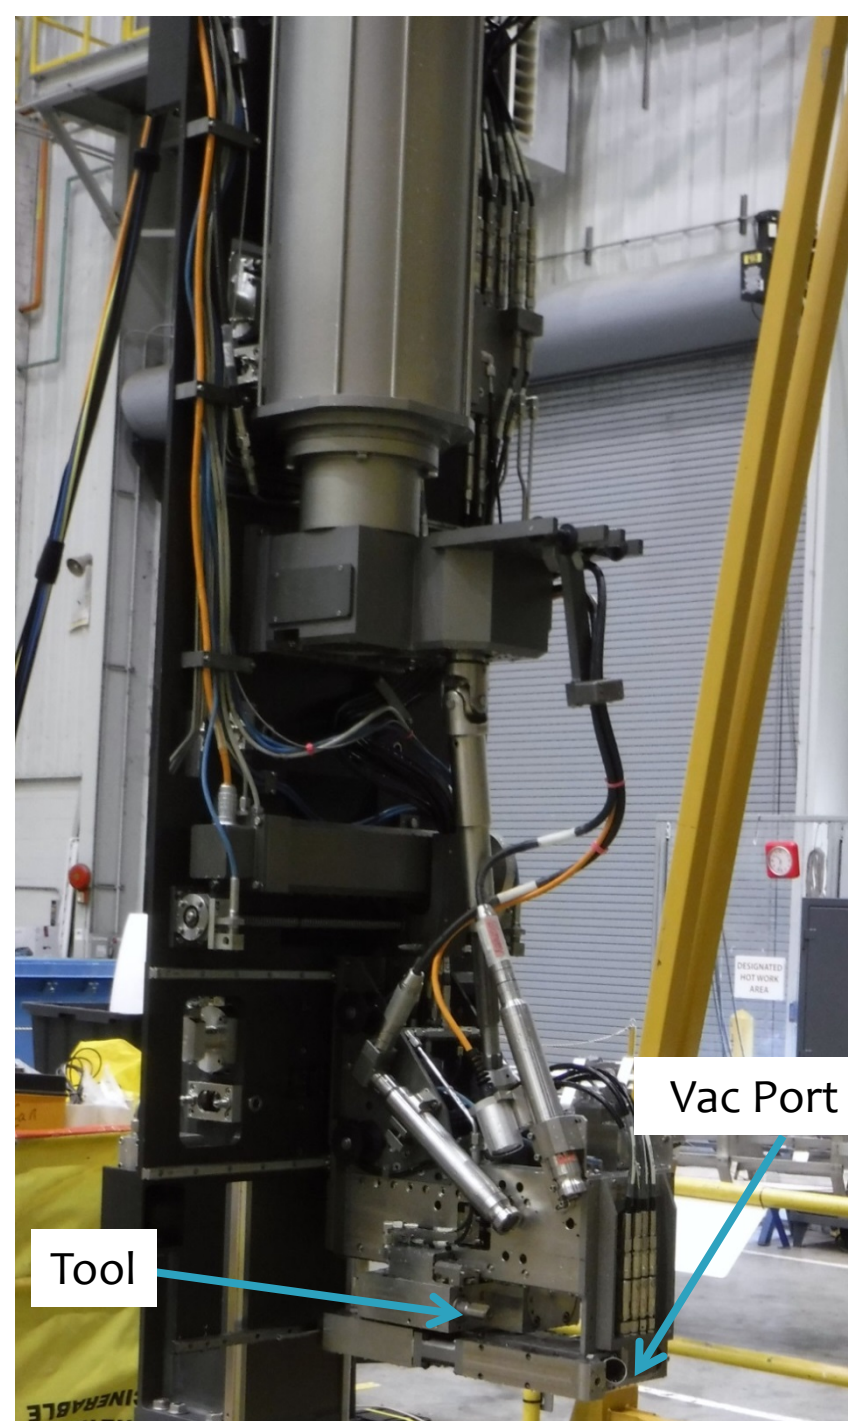
# Baffle Bolt Tooling Surveys, cont.

- ▶ Once the 3ft water readings are satisfactory the tool is raised to 1ft out of water
  - The same areas are surveyed
- ▶ Once the 1ft readings are satisfactory the Carriage is raised to the Bridge level and an Ion Chamber reading is obtained on the Tool

- ▶ When the tool stops at 3 ft below the surface, verify contact readings on entire carriage assembly, focusing on the tool head in extended position, vacuum inlet, and the vacuum elbow. (Stop work conditions are  $\approx 30$  mSv/hr)

- ▶ Bring the tool to 1 ft above the surface of the water, obtain contact and 30cm readings on the hottest spot on the carriage (typically on the tool head area, vacuum inlet, or the vacuum elbow) **Dose rates must be less than 8 mSv/hr @ 30 cm to continue**
