# Activities to reduce radiation exposure during outages of Ikata Power Station Unit 3

October, 2024

Shikoku Electric Power Co., Inc

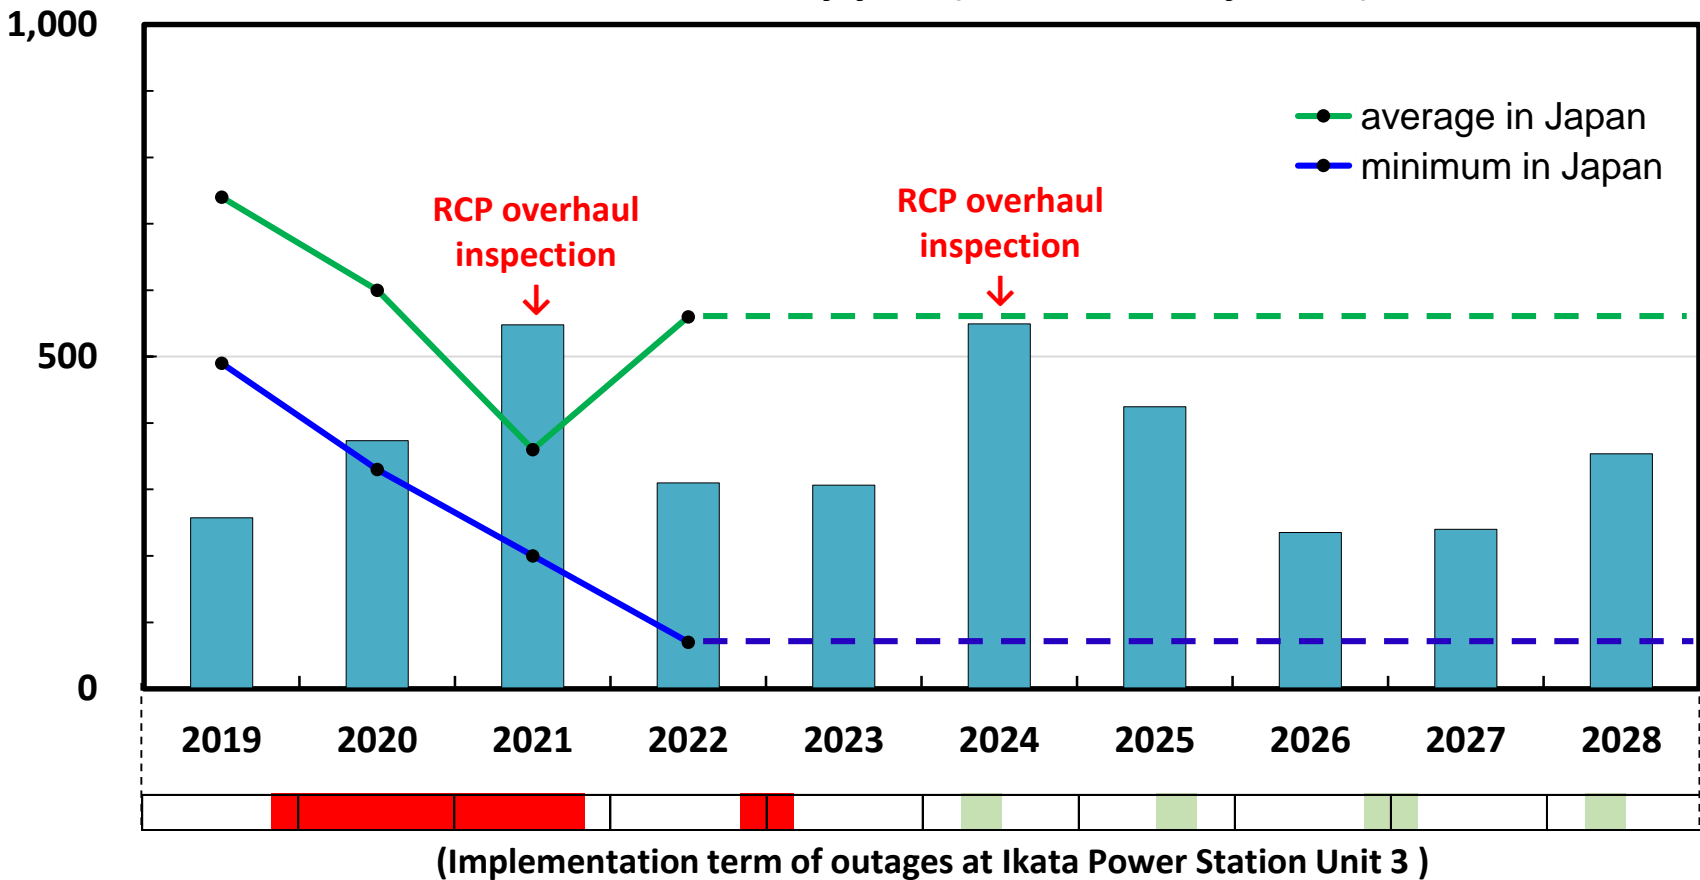
### Total dose by year (result and objective)

( person-mSv )

As for the mid- to long-term dose objective (~2028), it is expected to be below the average of restarted plants in Japan, but the objective may change depending on the construction details of outages and the full-scale start of decommissioning of Unit 1 and 2.

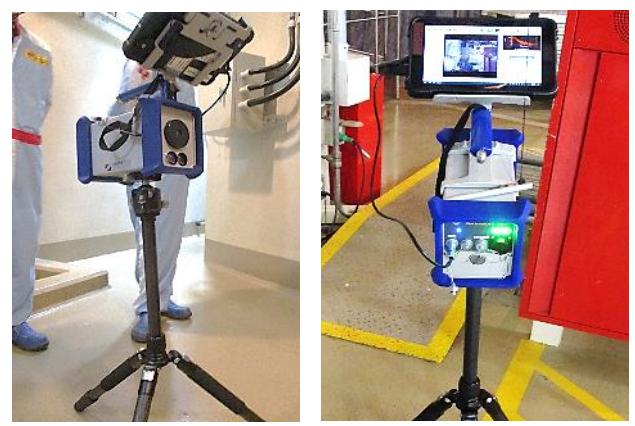
▼Camera Body

Introducing a radiation distribution visualization camera(2023~)

▶**Performance**  
It is possible to identify location and visualize of radiation source.  
(This camera can detected gamma rays.)

▶**By overlaying the radiation distribution on the optical image, the location of the radiation can be determined.**  
(Real time measurement is possible)

▶**By measuring the distance from the object using the built-in range finder, the approximate dose rate of the source can be estimated.**

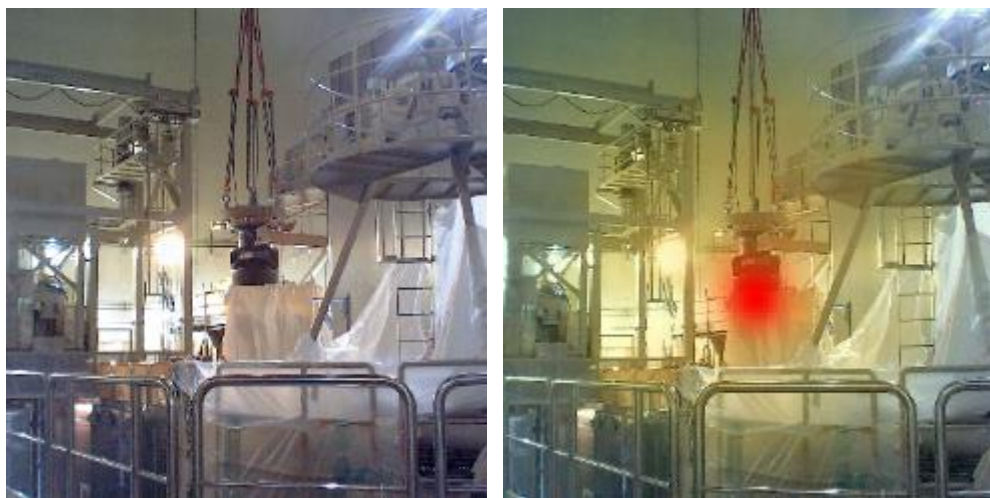
▼Measurement results (Hoist RCP Internal)

◀Measurement results (「multicolor display」)

left side : Normal Image  
right side : Measurement screen

※The displayed color changes depending on the intensity of the dose distribution.

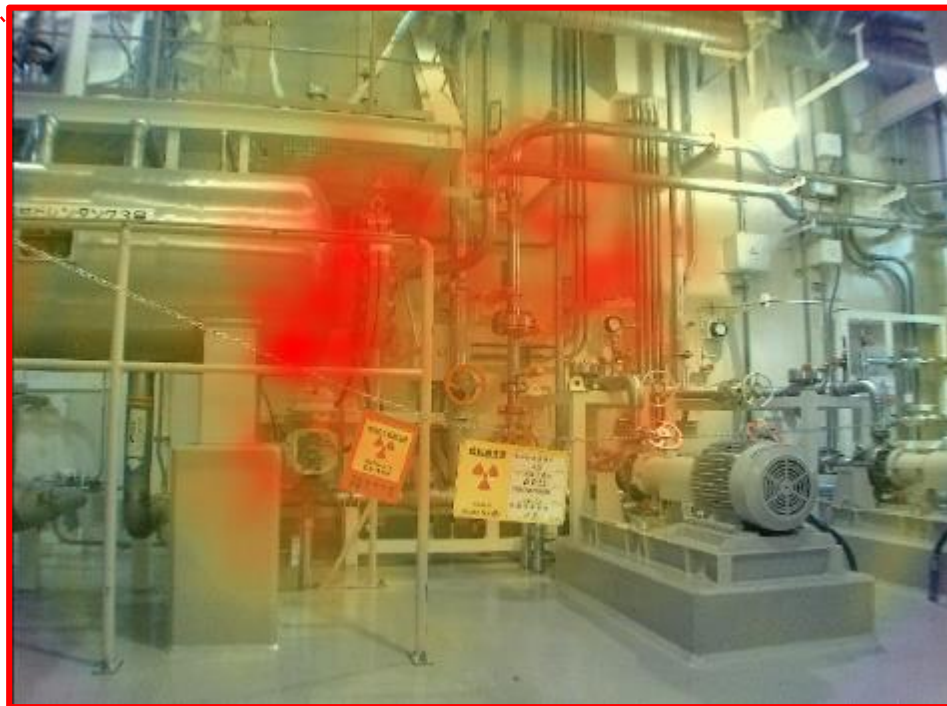
▼ CVCDT※ (during outages)

**【 Utilization results 】** Dose distribution maps posted at high dose equivalent rate areas.

※ Containment Vessel Coolant Drain Tank

► By posting the analysis results from the radiation visualization camera on-site, locations within the area with high dose equivalent rates can be visually recognized.

→ **Effective in reducing frequency of approaching high dose rate areas!**

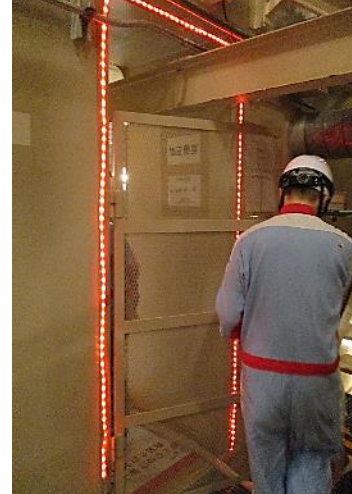
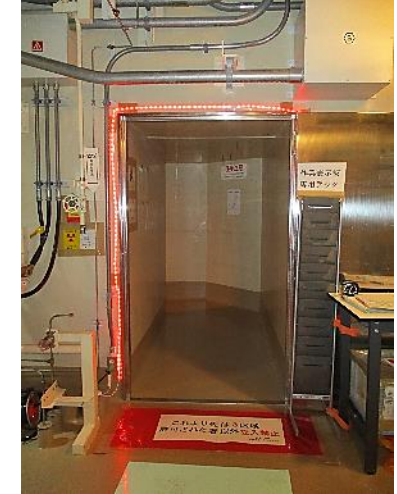
### • illumination

(for alerting people to high dose equivalent rate locations)

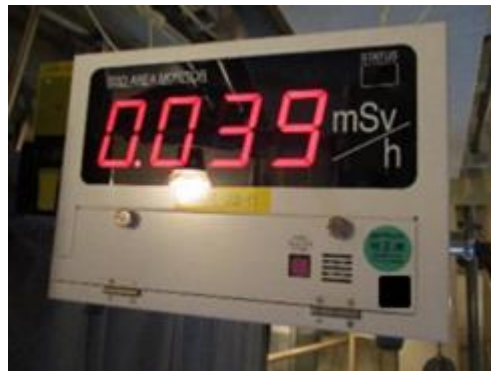
### • Gamma ray area monitor

(For air dose measurement)
